MEASUREMENT OF FLYING QUALITIES OF A DEHAVILLAND

MOSQUITO F-8 AIRPLANE (AAF NO. 43-334960)

I - LATERAL AND DIRECTIONAL STABILITY

AND CONTROL CHARACTERISTICS

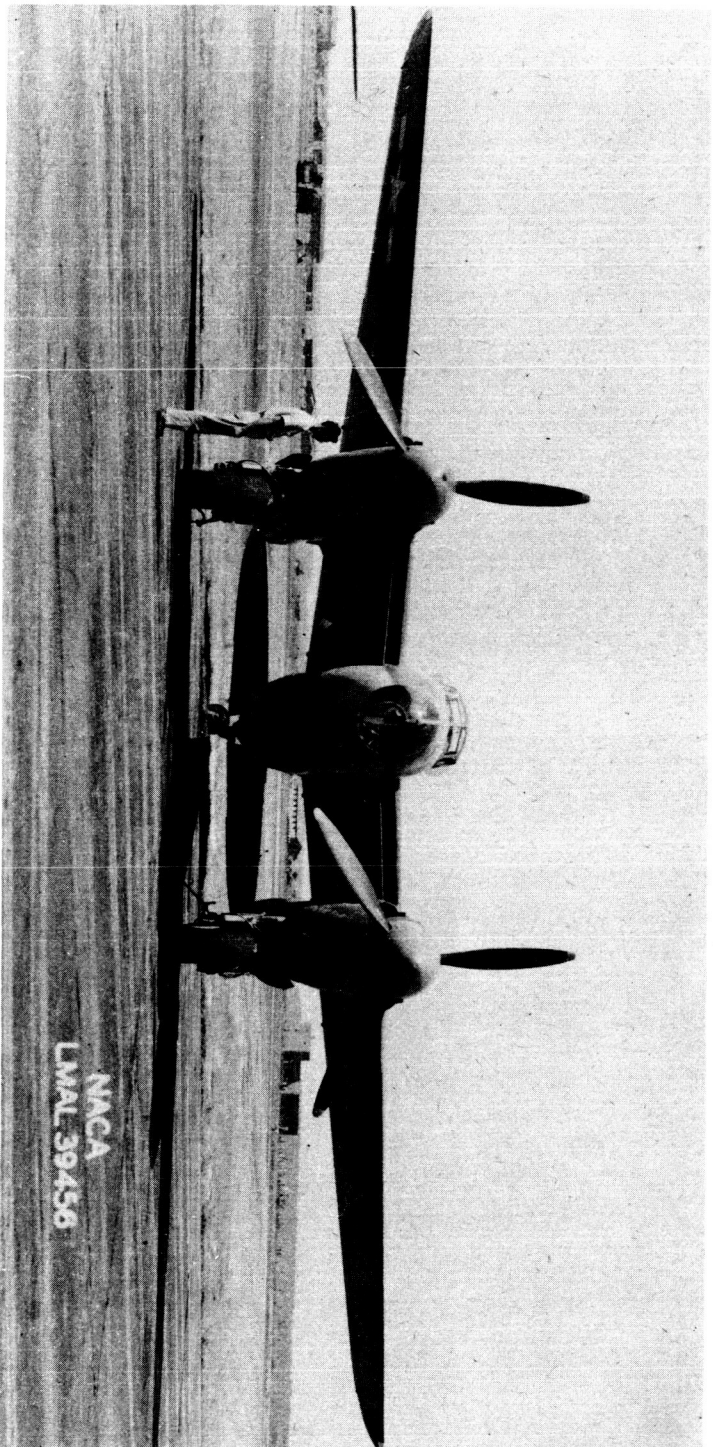
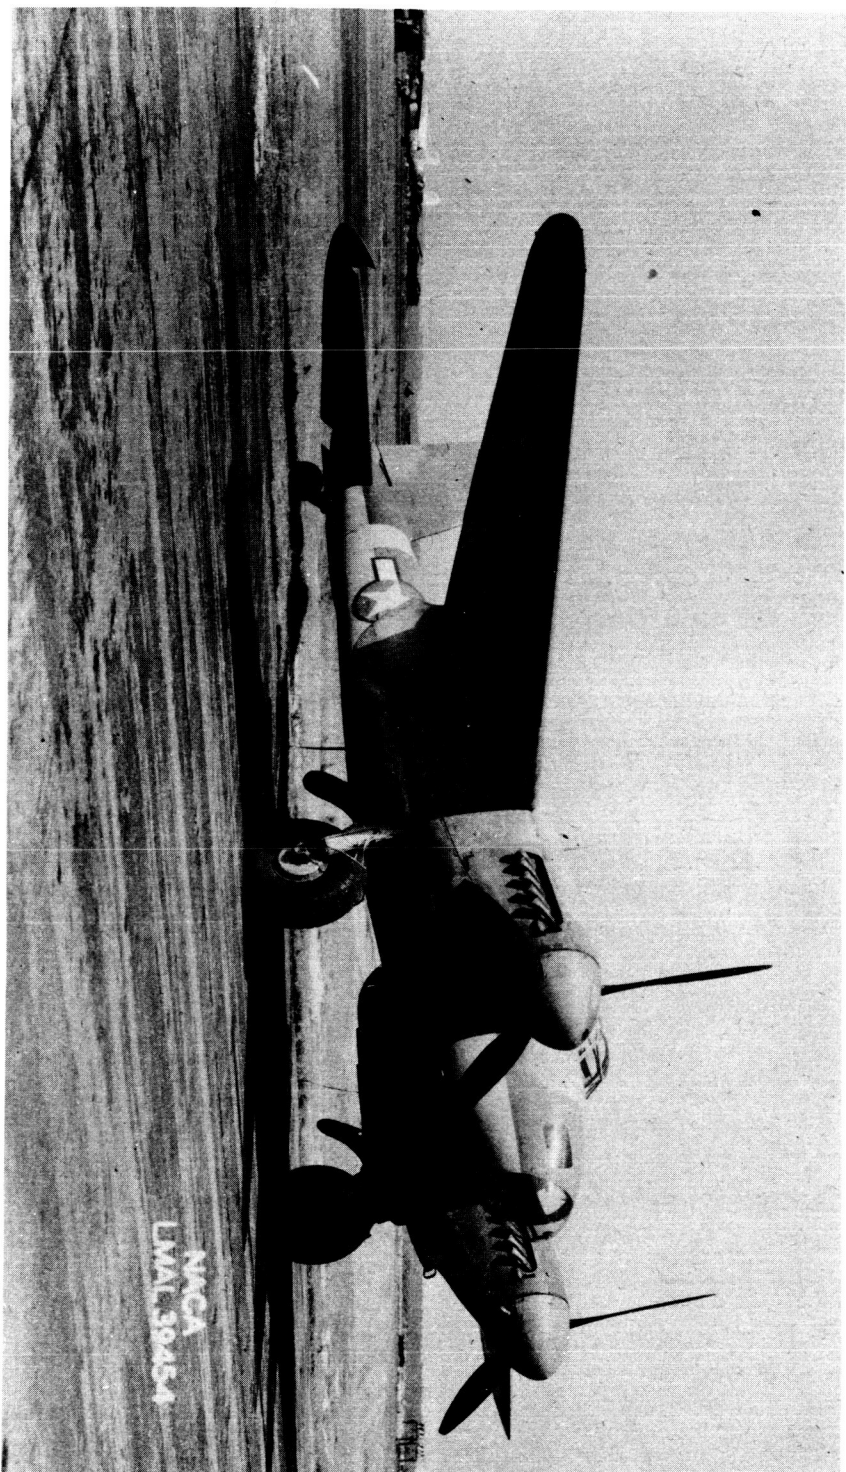
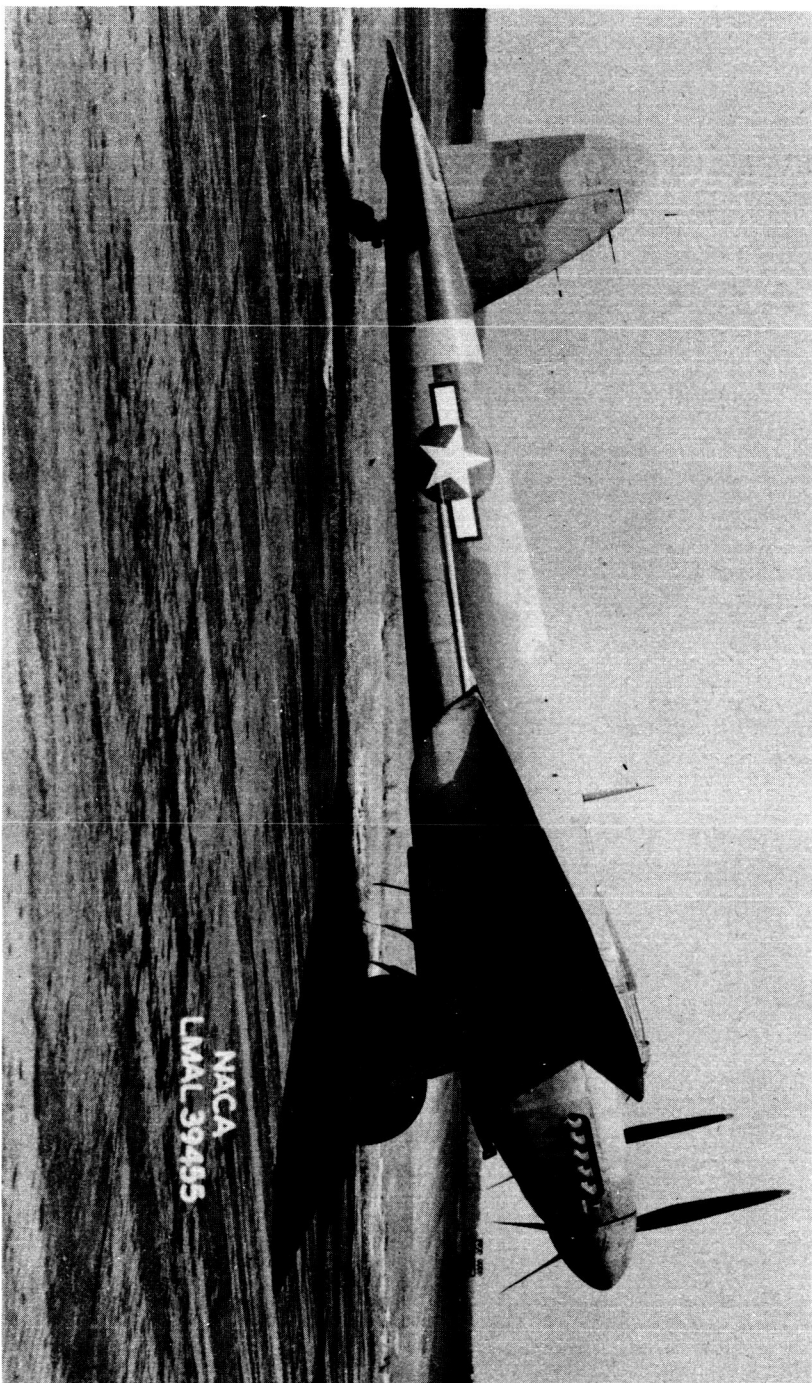
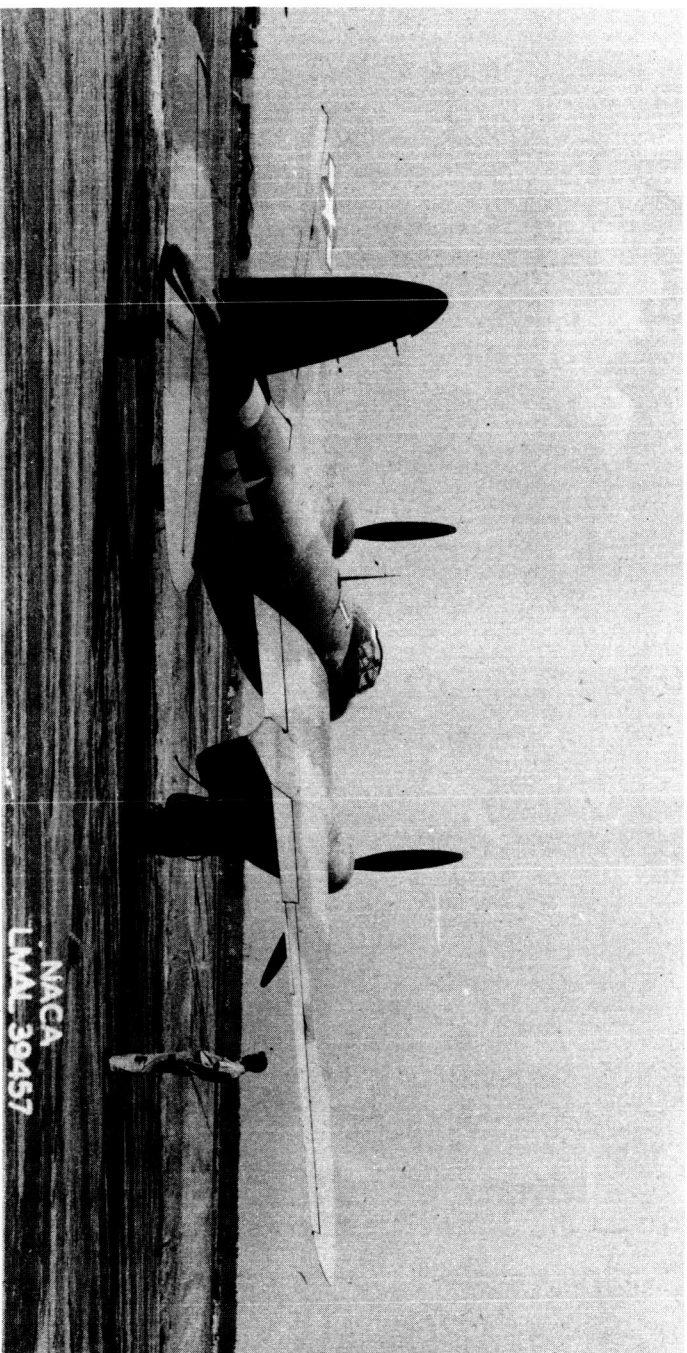
(a) Front view.

Figure 1.- Photographs of a DeHavilland Mosquito F-8 airplane.

(b) Three-quarter front view.

(c) Side view.

(d) Three-quarter rear view.

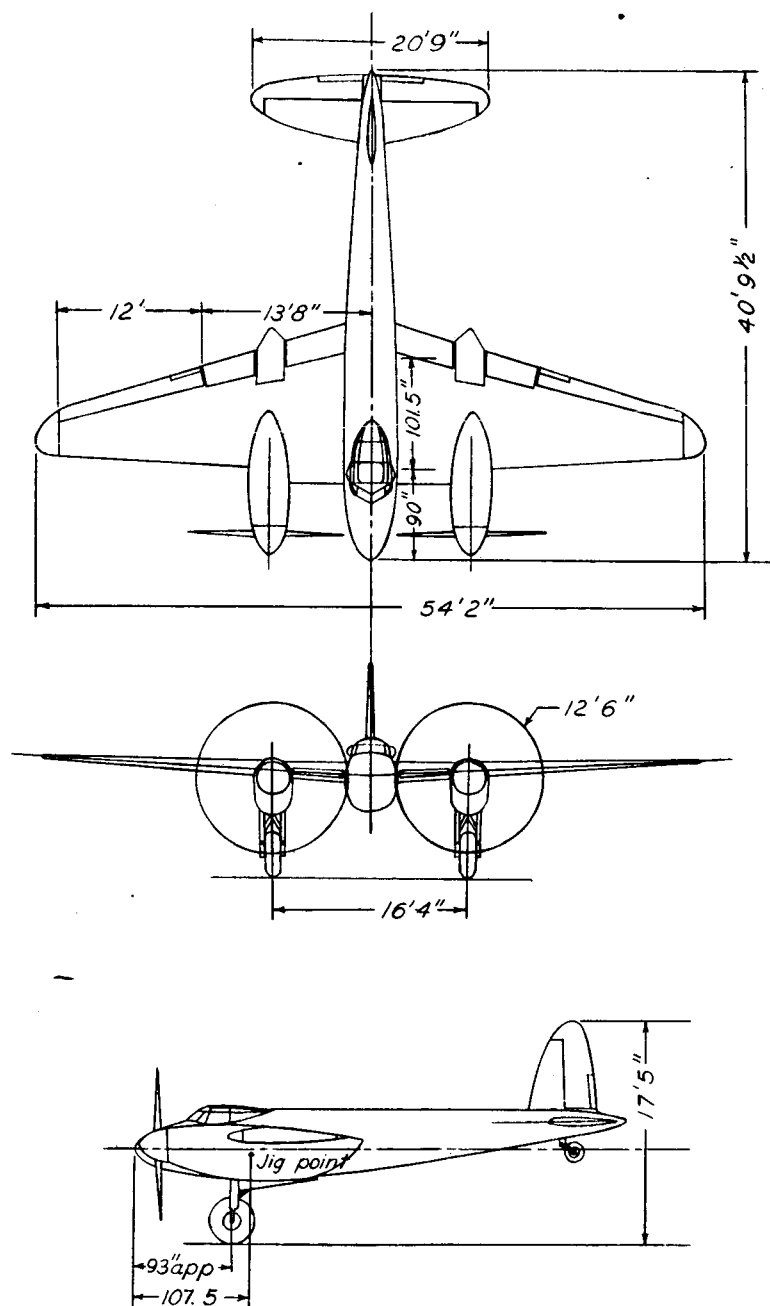
Figure 2. - Three-view drawing of DeHavilland Mosquito F-8 airplane.

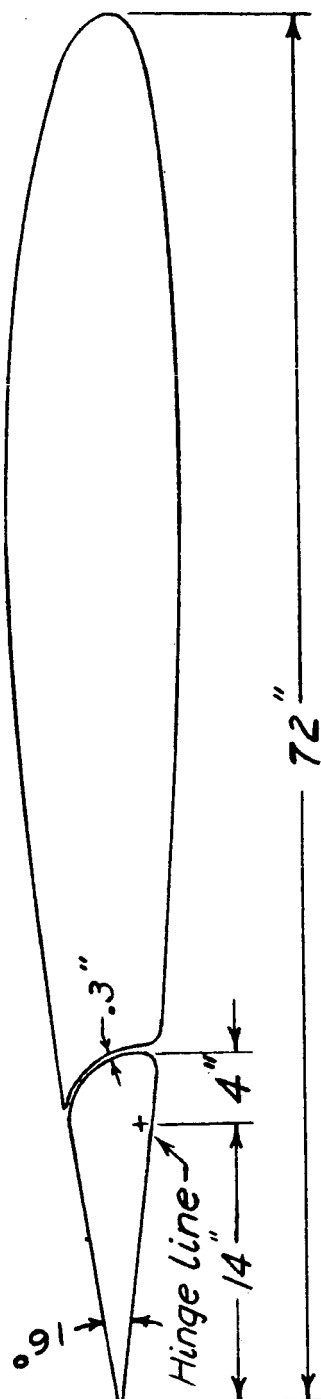
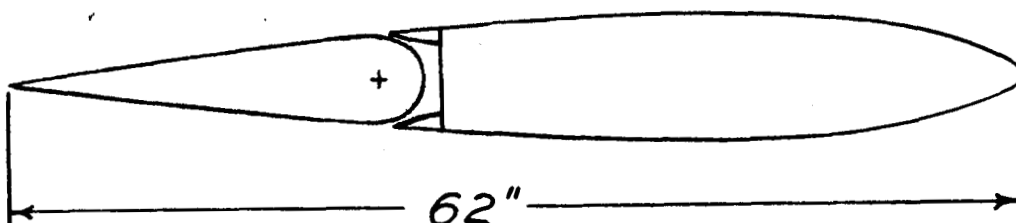
a. Wing and aileron  
Figure 3. - Section views of control surfaces, De-  
Havilland Mosquito F-8 airplane.

*Vertical tail at tip of fin*

*Horizontal tail 26" from centerline*

b. Horizontal and vertical surfaces  
Figure 3. - Concluded.

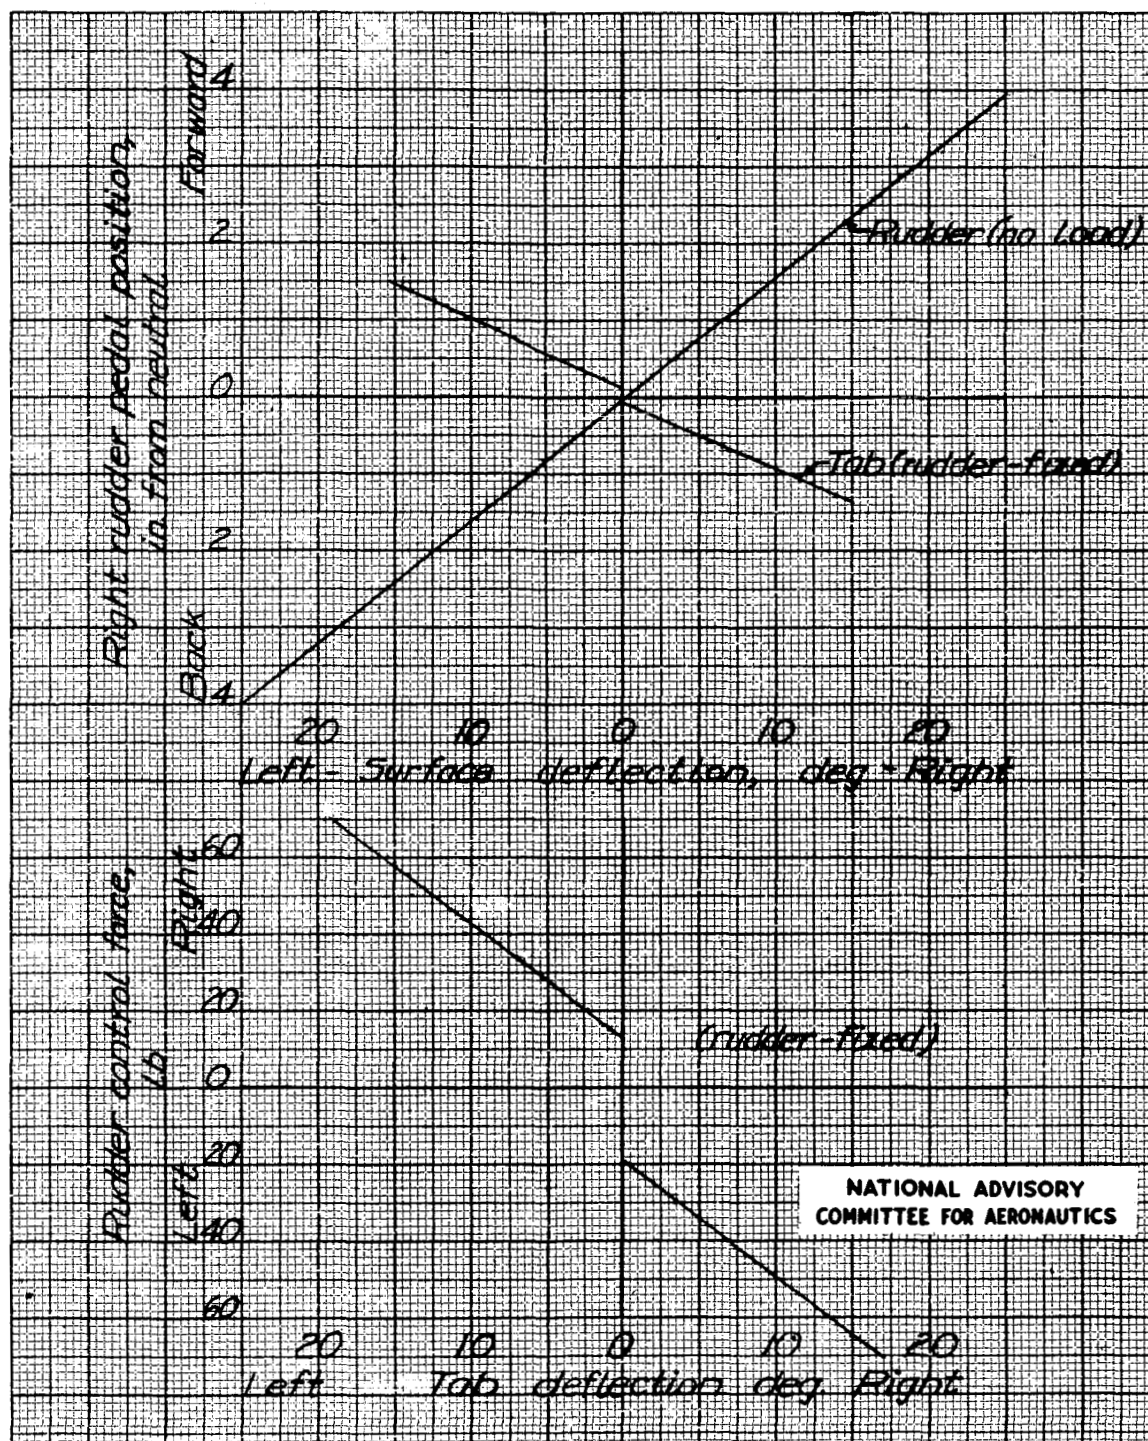
Figure 4. - Spring-tab rudder characteristics,  
DeHavilland Mosquito F-8 airplane.

Figure 4 presents the characteristics of the spring-tab rudder. Rudder deflection was measured with respect to the fin which was set parallel to the thrust axis. The friction of the rudder system amounted to  $\pm 5$  pounds of pedal force. Figure 5 shows the variation of aileron position with control-wheel deflection and figure 6, the variation of aileron balancing tab-position with aileron position. The friction in the aileron system was approximately  $\pm 4$  pounds for small deflections and increased slightly at large deflections.

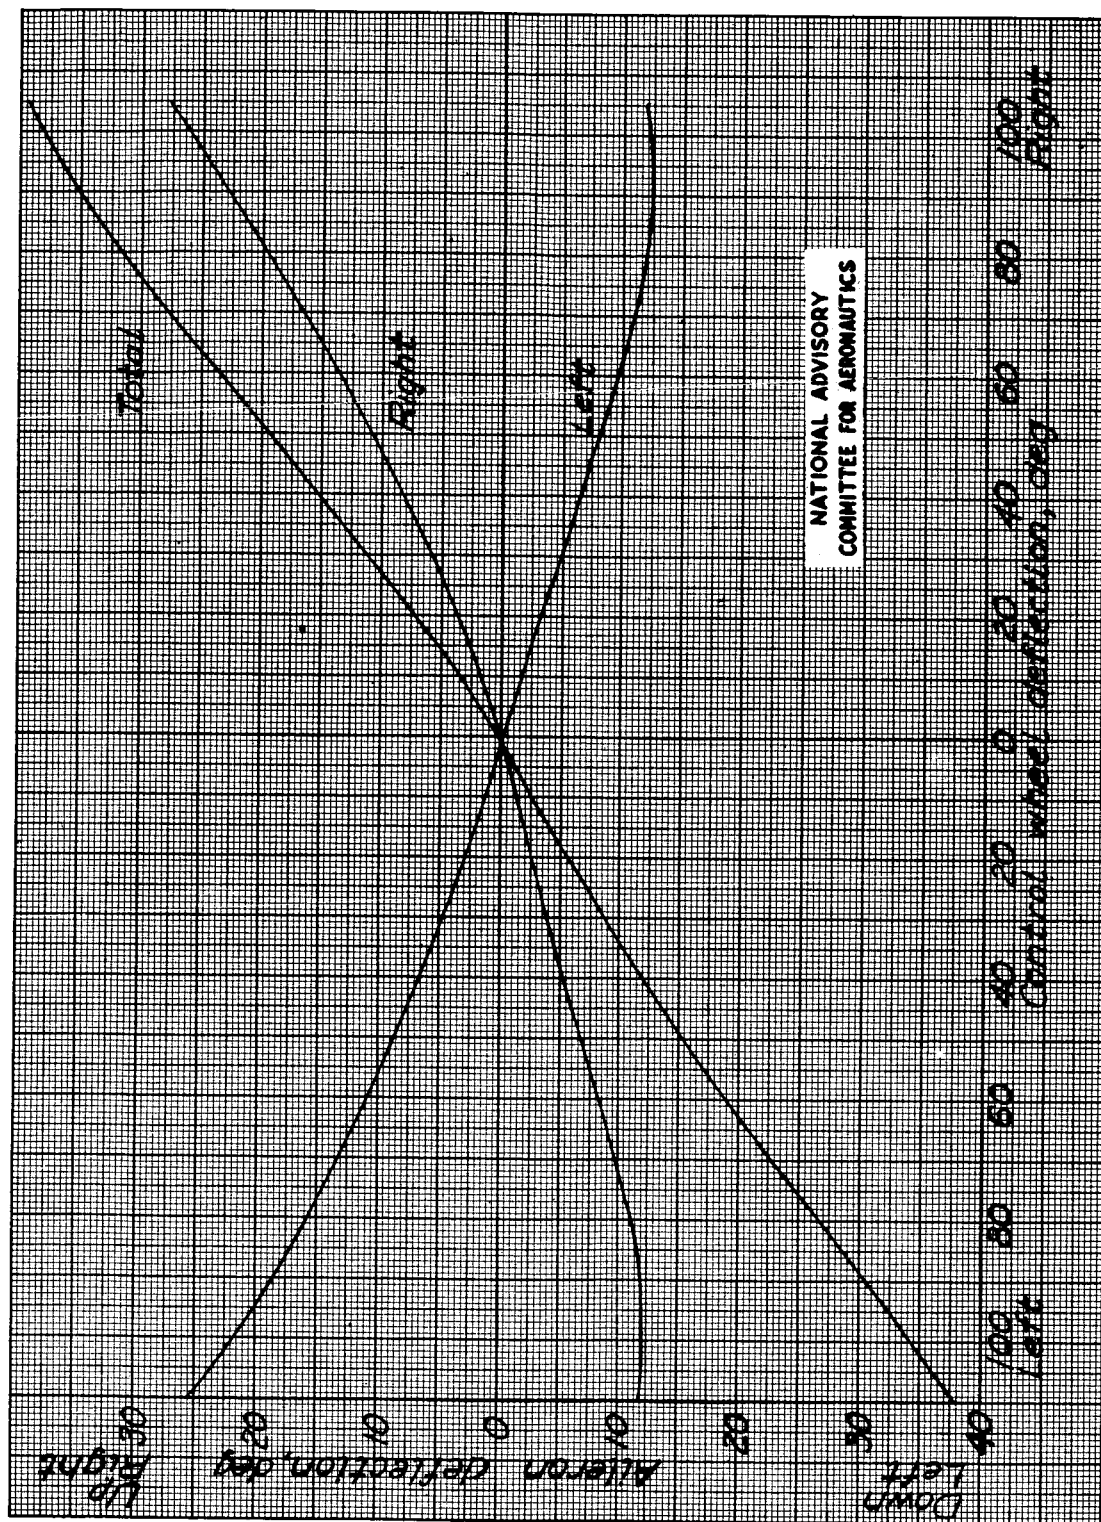
Figure 5. - Linkage between ailerons and control wheel, DeHavilland Mosquito F-5 airplane.

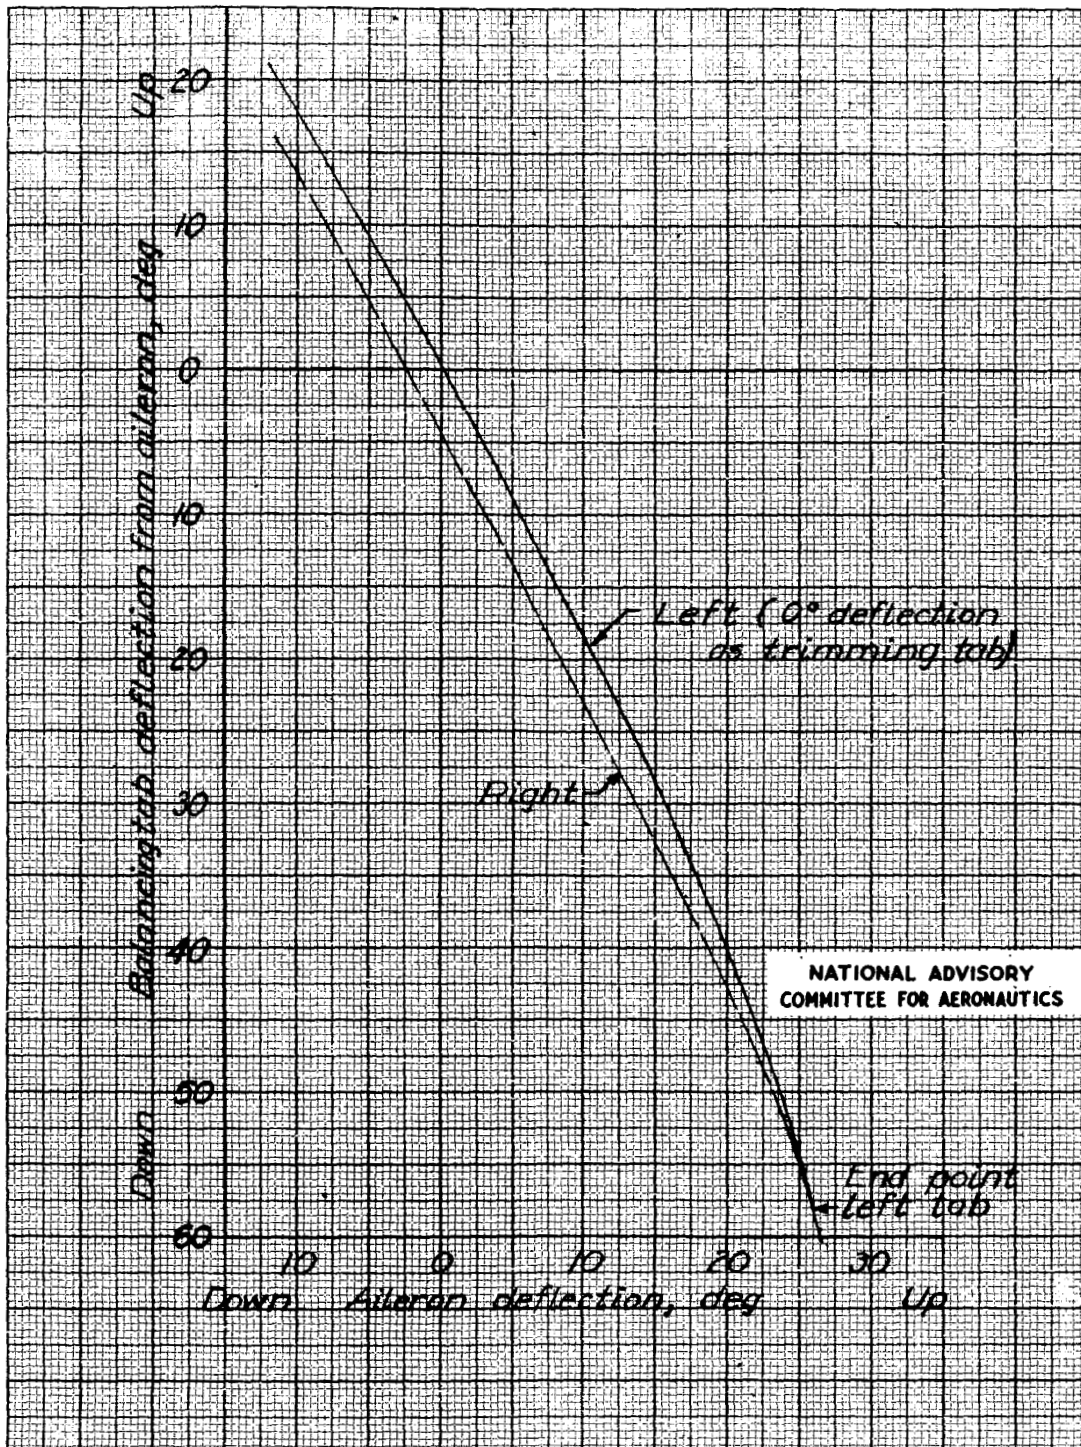
Figure 6. - Variation of balancing tab deflection with aileron deflection, DeHavilland Mosquito F-8 airplane.

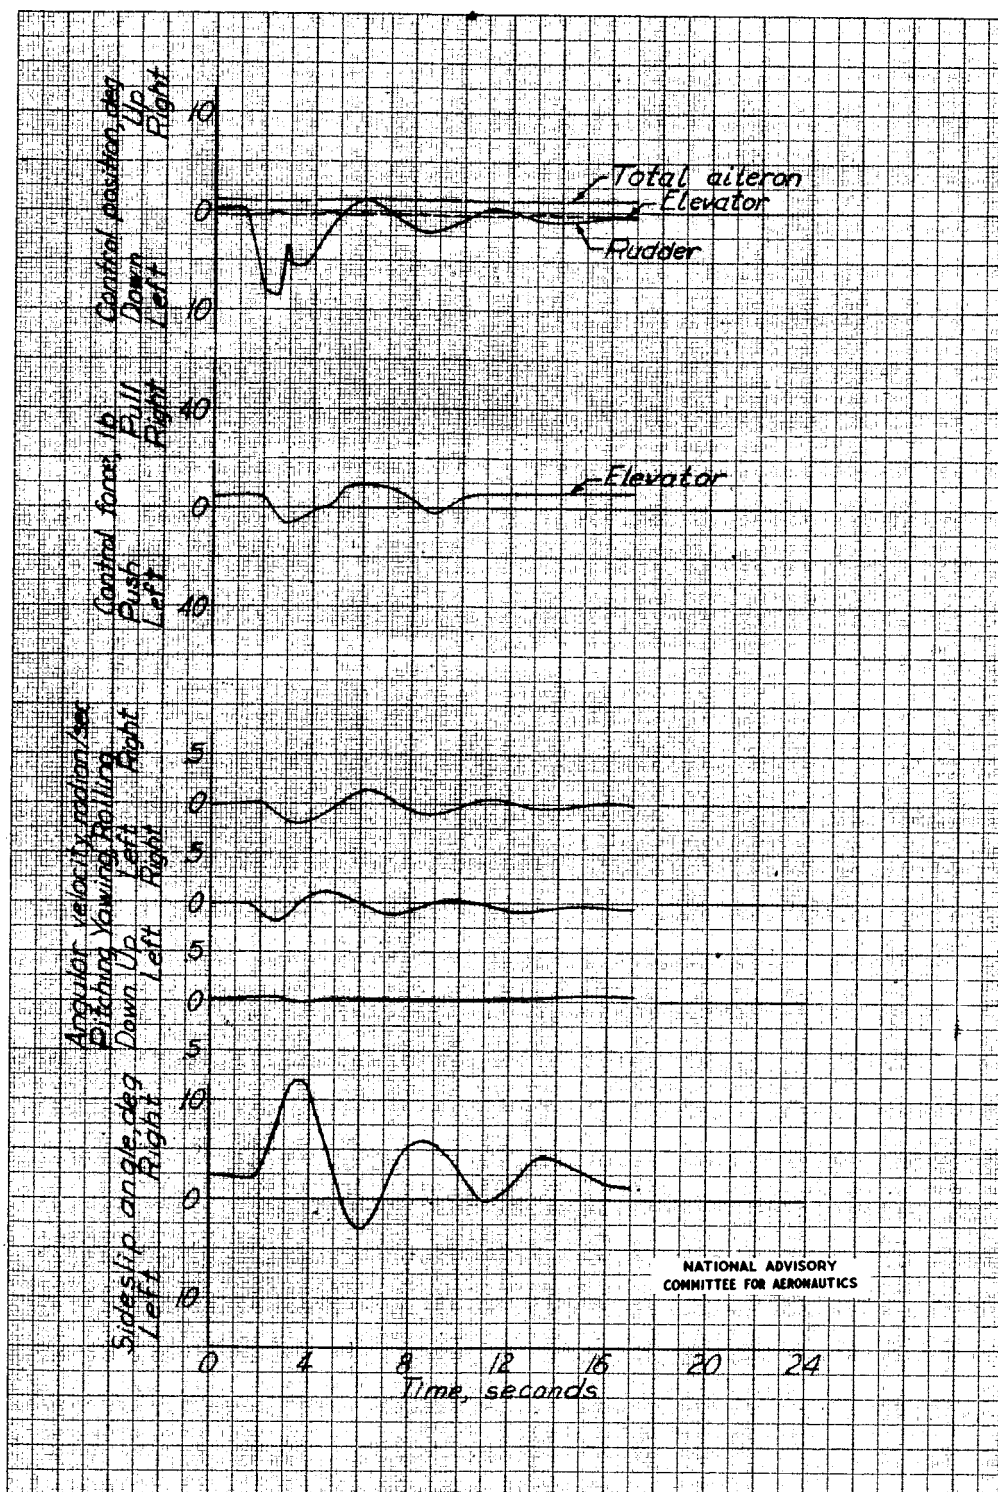
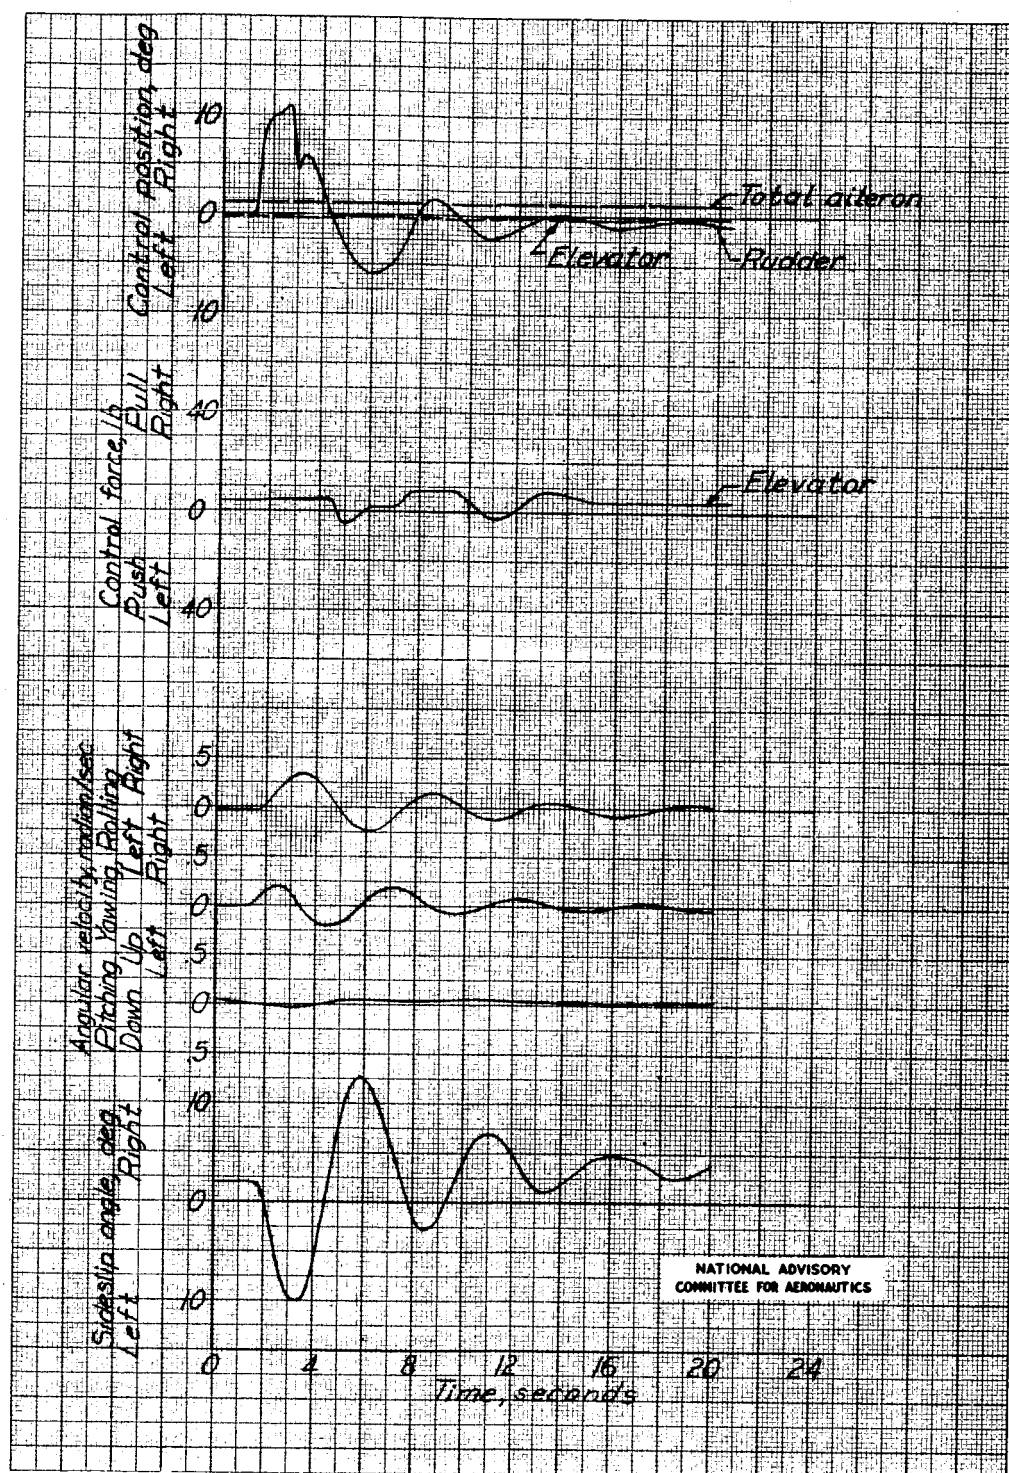
a. Left kick and release.  
Figure 7. - Lateral oscillations in the clean condition  
at 180 miles per hour with power for level  
flight (2650 rpm, 4 pounds boost), shutters  
closed, DeHavilland Mosquito F-3 airplane.

b. Right kick and release.  
Figure 7. - Concluded.

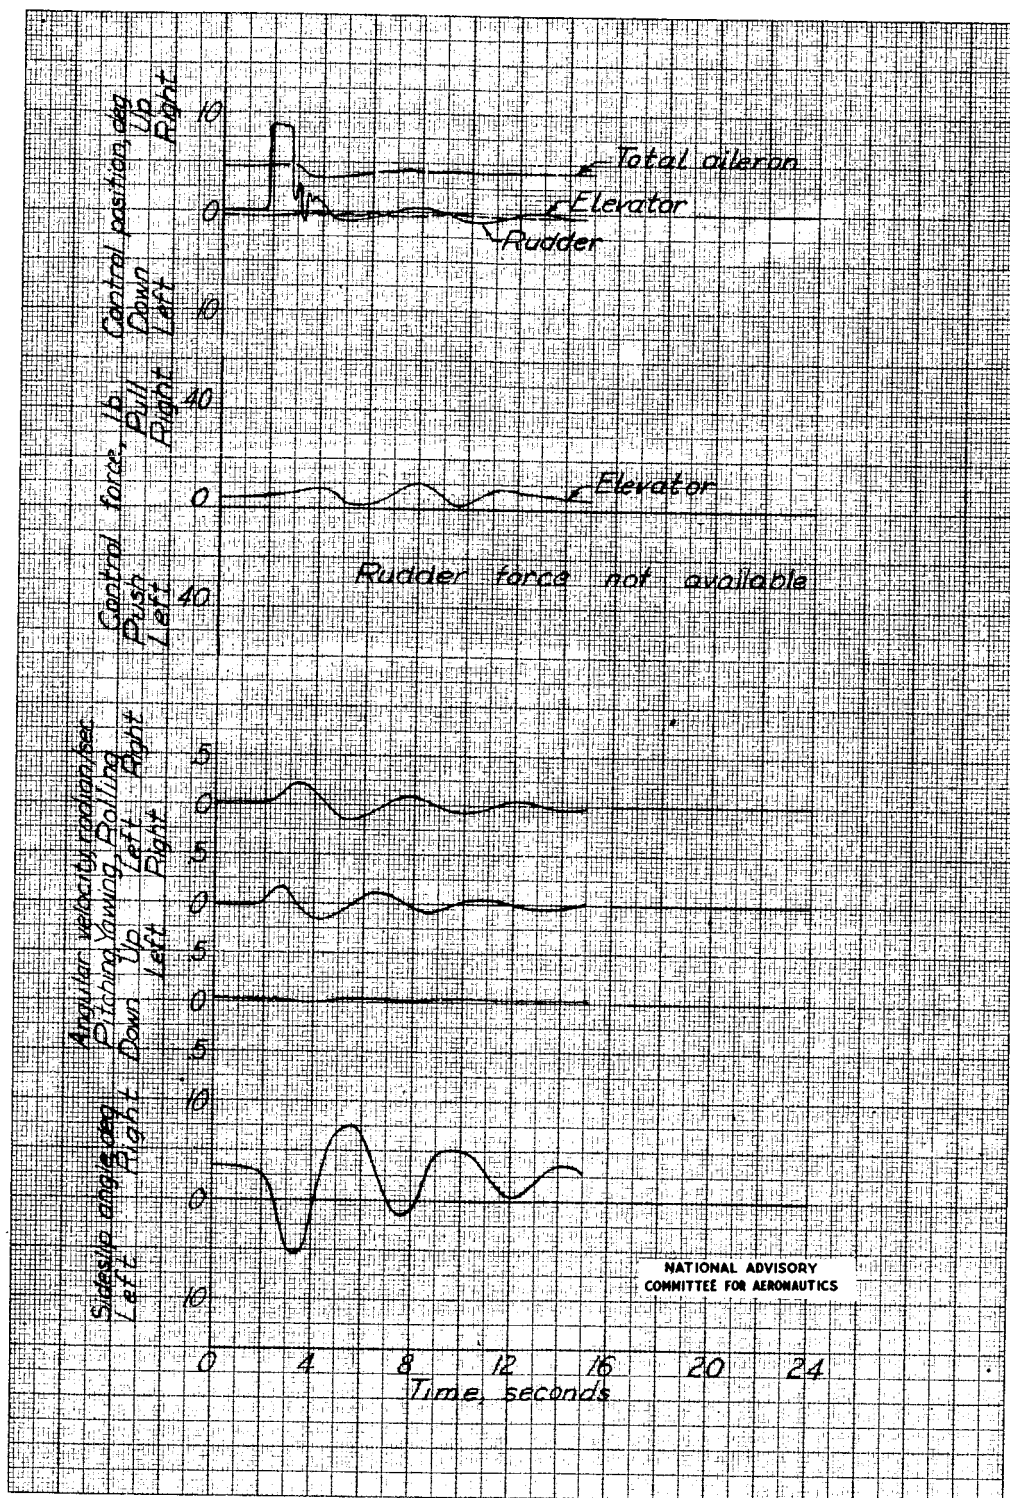
Figure 8. - Lateral oscillations in the clean condition at 180 miles per hour with power for level flight (2650 rpm, +4 pounds boost), shutters closed, caused by kicking the rudder and then fixing it in neutral, DeHavilland Mosquito, F-8 airplane.

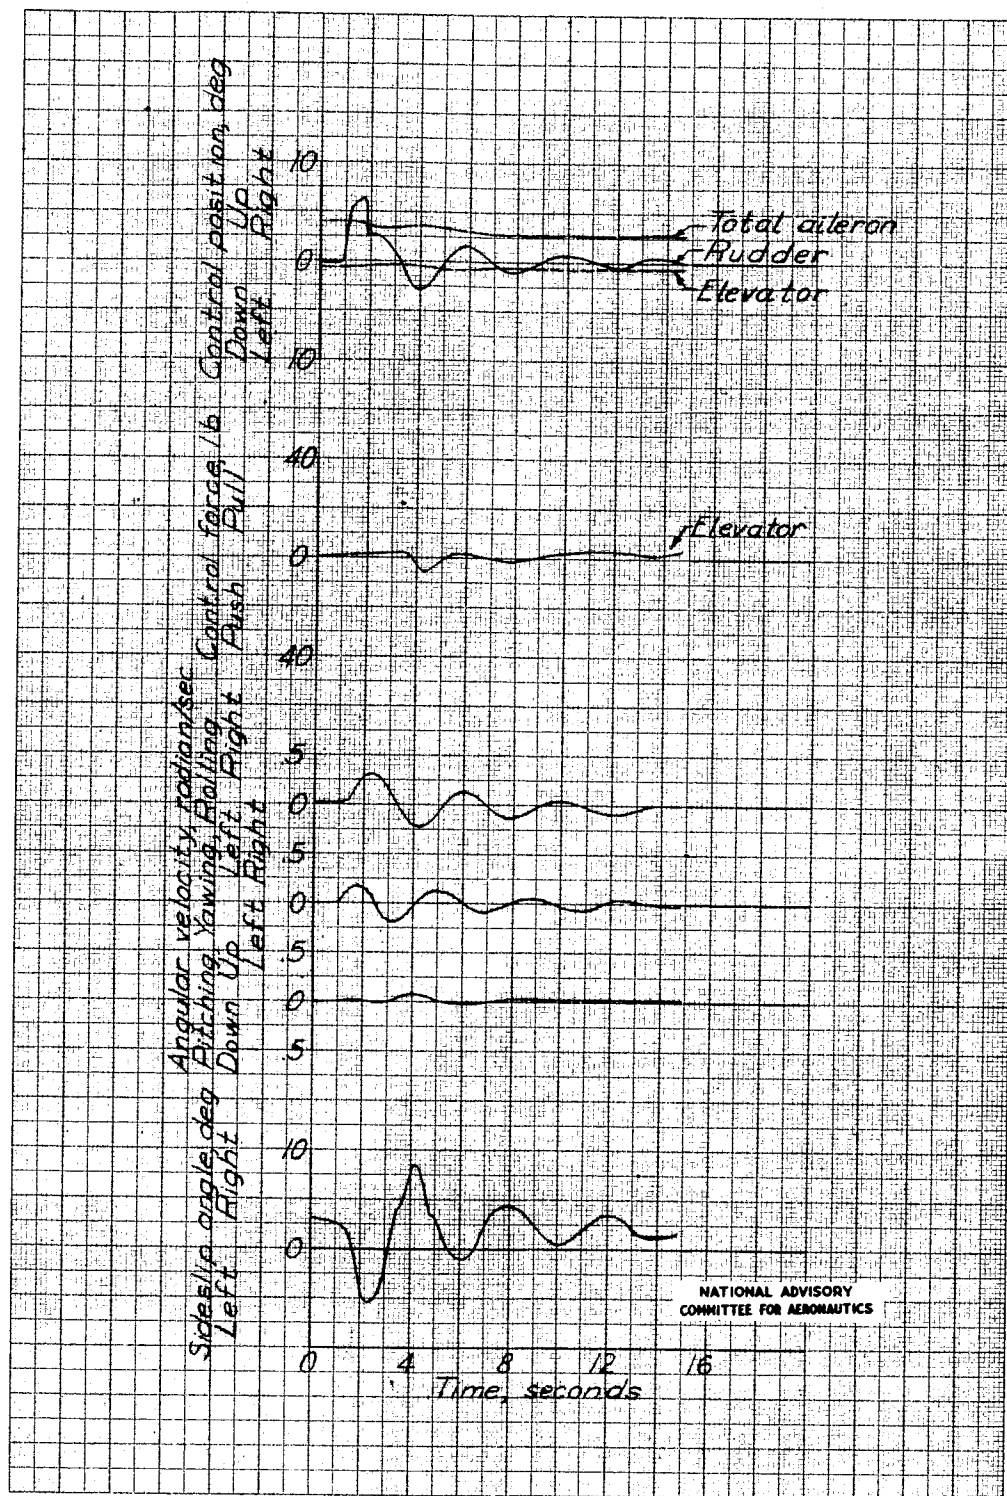
Figure 9. - Lateral oscillations in the clean condition at 280 miles per hour with rated power (2650 rpm, +7 pounds boost), shutters closed, caused by right rudder kick and release, DeHavilland Mosquito F-8 airplane.

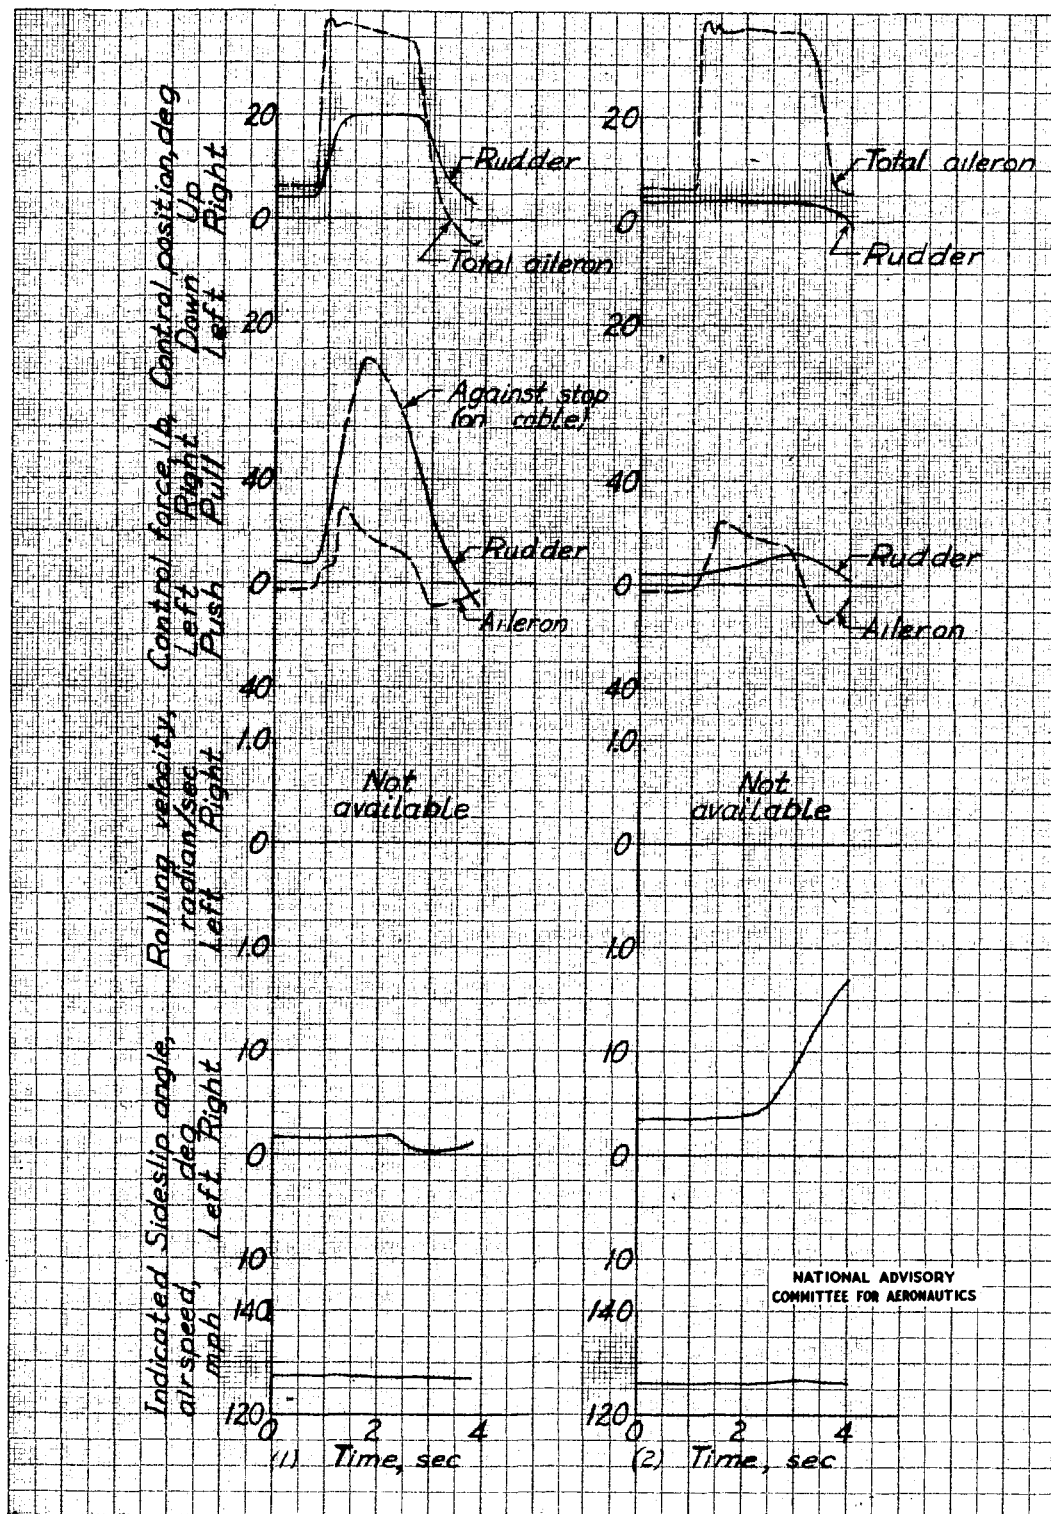
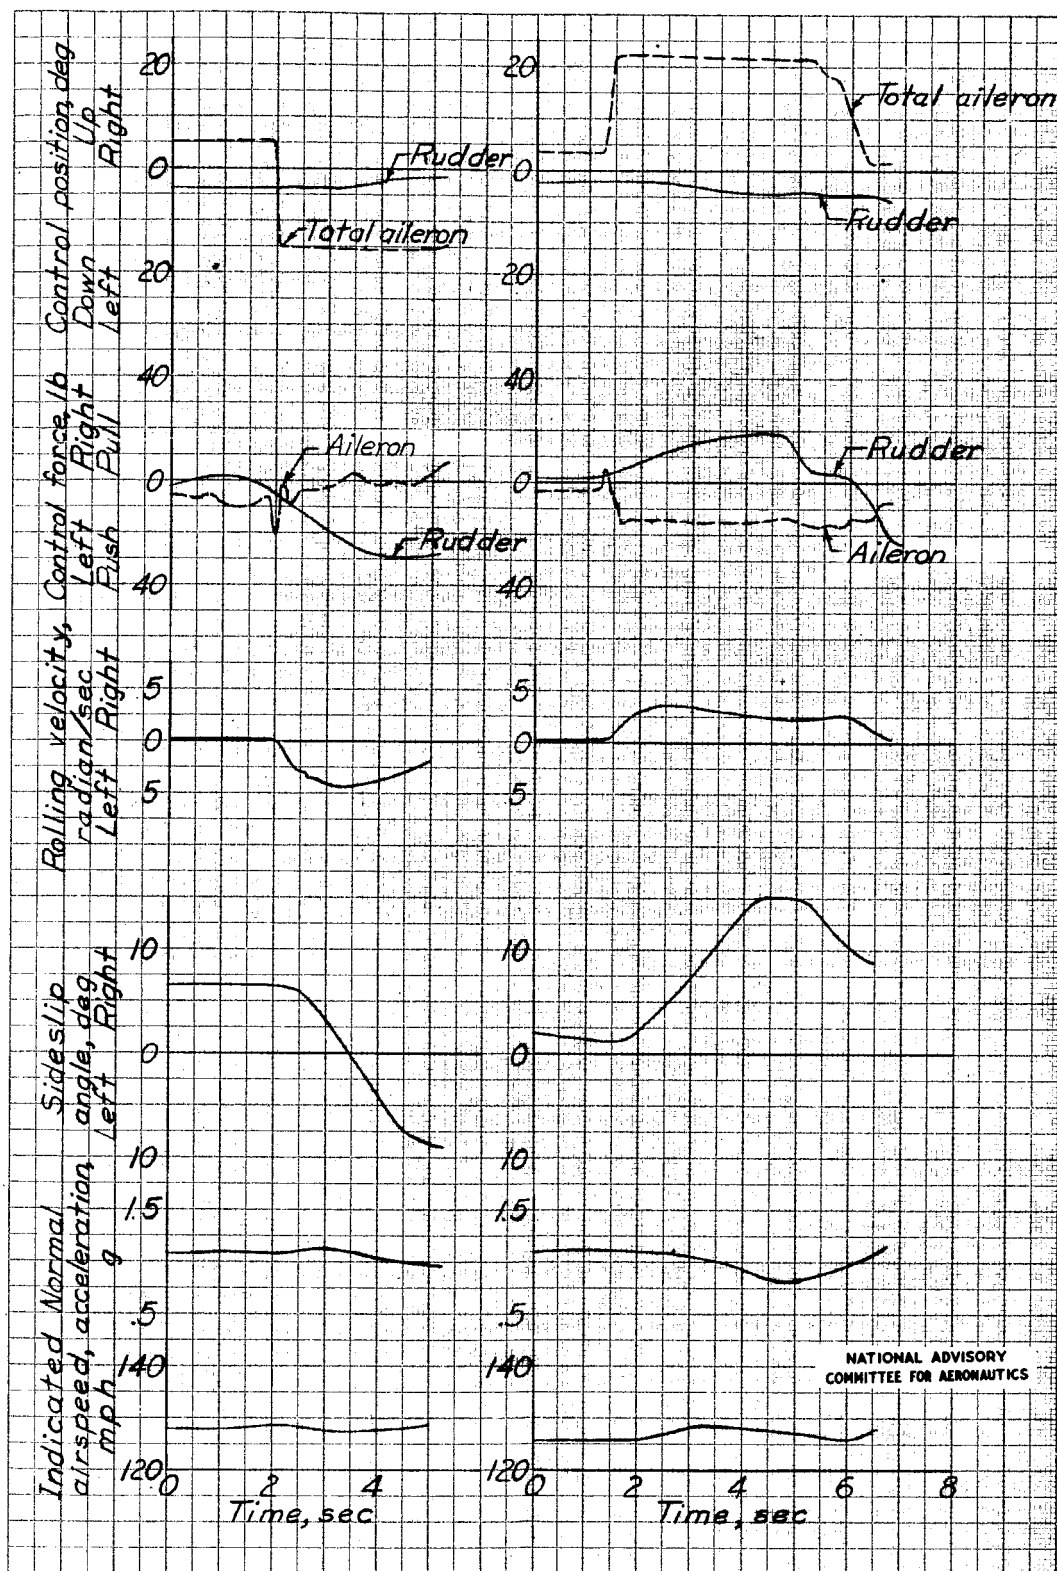
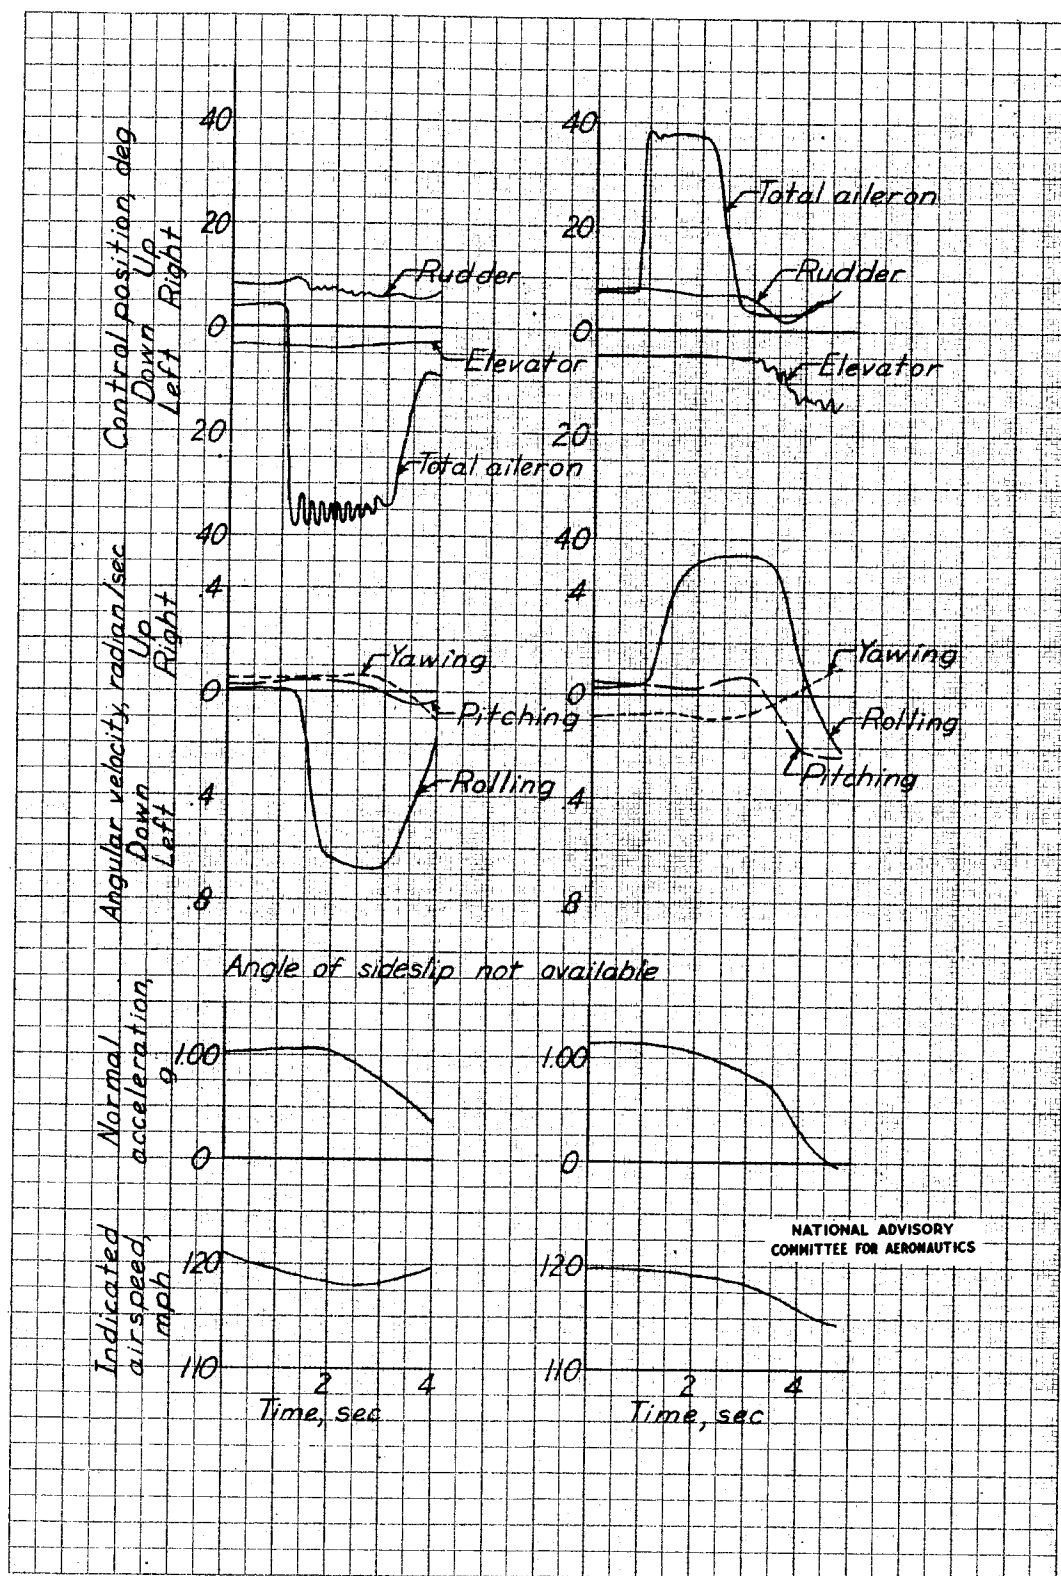
- a. Right rollouts with flaps down, landing gear down, power for level flight, shutters open, at 125 miles per hour.  
 (1) Using rudder to overcome aileron yaw.  
 (2) Rudder-fixed.

Figure 10 - Time histories of rolls out of turns, DeHavilland Mosquito F-8 airplane.

b. Rudder-fixed rollouts, with flaps up, landing gear up, engines idling, shutters closed, at 125 miles per hour.  
Figure 10 - Continued.

c. Rudder-fixed left and right rollouts with flaps down, landing gear down, rated power, shutters open, at 115 miles per hour. Engines cut out during right roll when airplane pitched down.

coordinated rudder are given in figure 10. The variation of maximum angle of sideslip with total aileron deflection in rudder-fixed roll-outs at low speeds is presented for several conditions in figure 11. The directional stability as indicated by the data of figure 11 was about equal in the gliding and wave-off conditions and slightly greater in the landing condition. The maximum angle of sideslip due to aileron deflection reached in the gliding condition was over  $20^\circ$  and therefore the requirements of reference 1 were not met. It was not always possible for the pilot to continue the maneuver until a maximum angle of sideslip was reached because of the pitching moment due to yawing. In figure 10(c) two rudder-fixed roll-outs are presented for the wave-off condition at 115 miles per hour during which the airplane pitched down abruptly as indicated by the pitching velocity and normal acceleration and in the right roll caused both engines to cut out. This figure also shows aileron shaking which was often noticed when the ailerons were fully deflected.

Analysis of the data in figure 10 and other similar data indicates that nearly all of the available change of rudder deflection, approximately  $15^\circ$  right or  $20^\circ$  left, and approximately a 50-pound increment of rudder force were necessary to overcome the yaw due to full aileron deflection at 125 miles per hour with flaps and gear down, power for level flight. The requirement of reference 1 that the rudder be able to overcome the adverse yaw due to full aileron deflection with a rudder force of less than 180 pounds was satisfied, but the pilot commented that a considerable amount of pedal motion was required for the amount of aileron control applied.

figures 25 through 28 indicate that on this particular Mosquito aileron overbalance occurred in rolls in all conditions below 200 miles per hour over a considerable range of aileron deflections. It has been stated previously that the ailerons tended to shake when fully deflected and that an example of aileron shaking is presented in figure 10(c).
